## A Conjoint Analysis of the Design Irregularities and Public Realms of a National Highway in Bangalore

### ABSTRACT

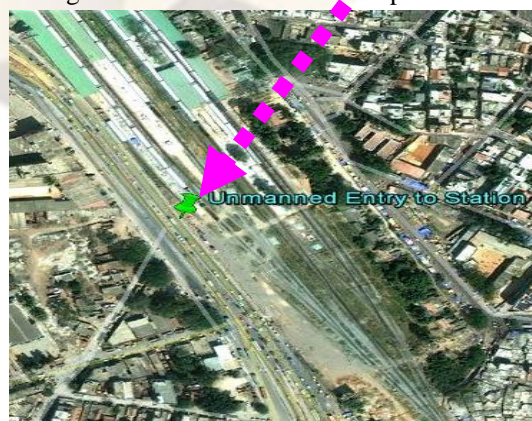
Fig. 2: Bird-View of Stretch under Scanner.

The study has been carried out at a walkway in one of the most congested and developed area – Yeswanthpur (figure 1) in Bangalore West, where NH4, connecting Mumbai and Bangalore passes alongside. While the area to the west of the walkway encompasses Yeswanthpur Railway station (figure 2) and residential outgrowth, the eastern side comprises of Peenya Industrial Area.

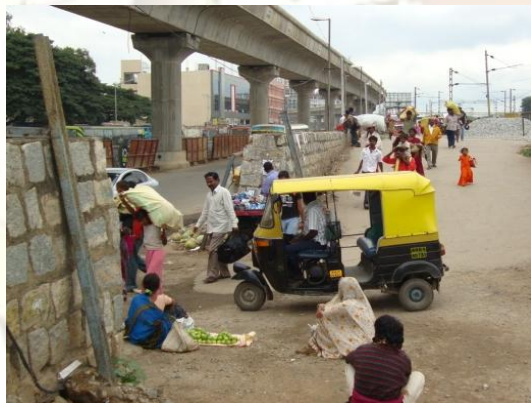
The study basically visualizes 40m of the walkway adjacent to an unmanned exit (figure 3) from the Yeshwanthpur Railway station. The visual access from the walkway to the rail terminal is interrupted by a large blank wall. The walkway also comprises of fruit vendors and other street hawkers, luring the potential customers entering and leaving the railway station.

Fig. 3: The unmanned exit from railway station.

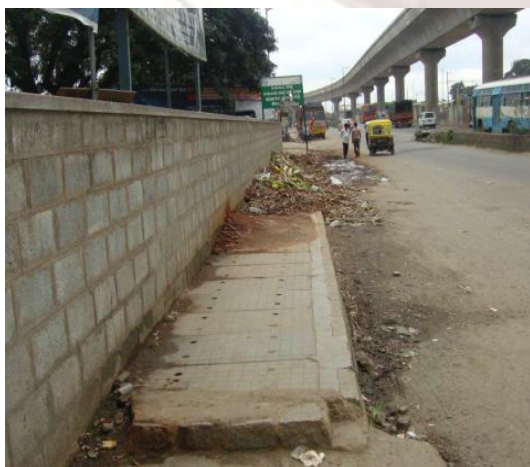
The survey confirmed that the walkway did not comply with the IRC standards, as its width was only about 1.2m (figure 4) and also lacked guardrails, compulsory requisite for all National Highways. The level of service for the walkway was found to be 'F', which is the lowest rating, as per Highway Capacity Manual (HCM) 2010. The stretch parallel to the walkway also houses a petrol bunk, an auto-rickshaw stand and an unsheltered bus-stop, adding to larger agglomeration of public. Under the current circumstances, with less width and high pedestrian density, people often tend to walk on the road to save time and avoid collisions with other people, sharing the same space. This causes pedestrian spillover onto the main carriageway.

Fig. 4: The walkway under investigation.

The existing footpath width is only 1.2m, whereas as per IRC standards, the ideal width should have been at least 4m with provisions of guard rails and zebra-crossing, along with regular maintenance of the road infrastructure. The corrective measures must also incorporate fenestrations in the barricades, to establish a visual access, such that the link between them is enhanced by the urban public realm. Since sky-walkers or foot-over bridge cannot be incorporated with metro being commissioned, an 'I' shaped Subway (figure 11) having a width of 4m and vertical clearance of at least 2.5m, starting from the point of unmanned exit, leading to the other side must be provided. The subway apart from providing structural stability and necessary safety measures for pedestrians must also be pedestrian friendly, promoting its use. The subways, instead of being used solely for crossing can be made more interesting with activities like informal hawking, incorporated in the design itself. Informal hawking in the subway would not only enrich the experience of the pedestrians who use it, but also would help in maintaining the place neat and clean.

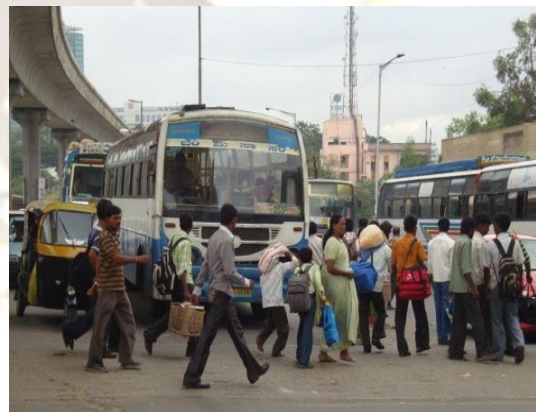
Fig. 5: Traffic Disruption by pedestrians.

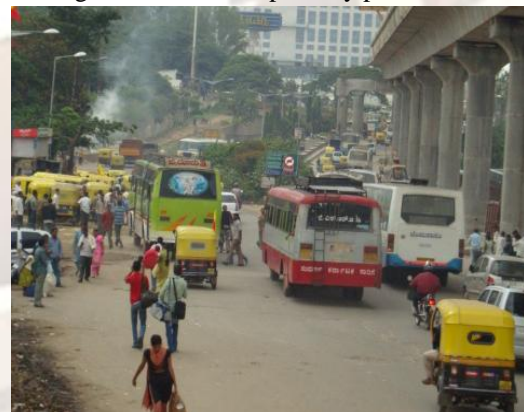
Fig. 6: Heavy traffic volume.

The width of the two-lane carriageway was found to be 7m with the maximum users being motor-bikes, followed by cars. The traffic volume (figure 6) along the walkway was found to be 38,498 alongside a disturbing hourly average pedestrian flow of 26. As there was no provision of zebra-crossing and median, the unruly crossing speed of pedestrians was found to be around 1m/sec, thereby interfering with the smooth flow of traffic, leading to delays.

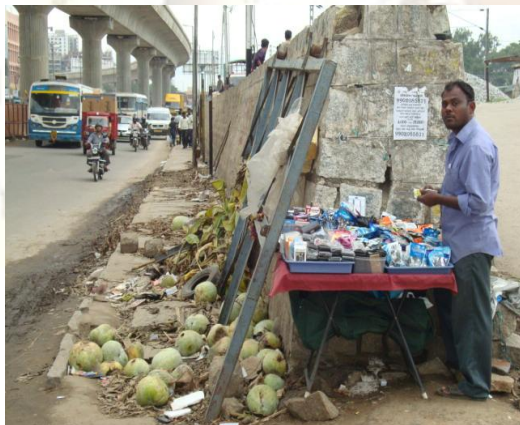
To aggravate the persisting problem of jaywalkers and high pedestrian density, the high blank wall demarcating the railway station and footpath, cuts the possible visual connection between the two, stimulating the abuse of the walkways by pedestrians and its encroachment by street hawkers (figure 7). As the other side is not visible, due to the presence of a huge wall along the footpath, the commuters or pedestrians tend to blemish the walkway (figure 8), by disposing garbage, spitting & urinating. Thereby, making the walkway a misfit, failing to actually serve its purpose. The use of walkway by pedestrians may also be biased by factors such as adjacent land-uses, its visual and physical connections with the walkway and the prevailing condition of the footpath. Instead of paintings and sticking pictures of deities on the wall to sensitize public, it is better to ensure cleanliness and hygiene, through transparency and design.

Fig. 7: Encroachment along walkway.

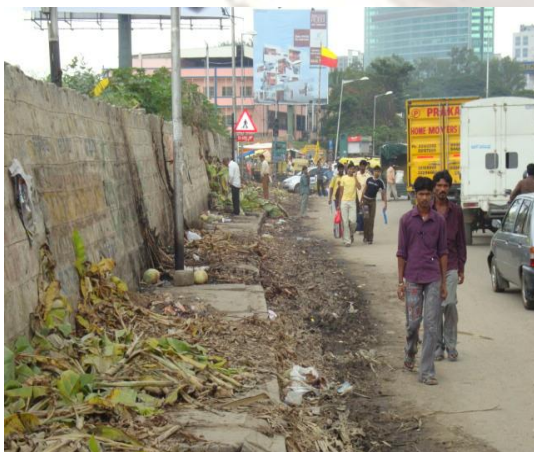
Fig. 8: Public abuse & spillover along walkway.

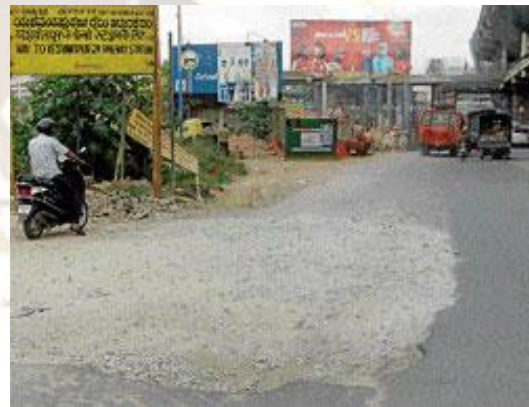
The solutions, envisaged for the current issue, have incorporated road widening, without any regard or consideration for the roadside elements contributing to the urban landscape. This has severely impacted the natural environment and elevated air pollution levels, compounding the loss of trees, which act as natural air-purifiers. Metro rail project, which has been initiated along this stretch to reduce stress on transportation and environment, has failed too, as it has added to the present congestion. With the commencement of the Metro construction, roads have deteriorated, with the top layer of the tarred road (figure 9) being worn out at several places causing dust pollution. Potholes and bottlenecks, introduced by Metro construction and its barricades have increased the waiting time and crossing time of vehicles, thereby hiking the rate of automobile exhaust.

Fig. 9: Widened Roads near stretch

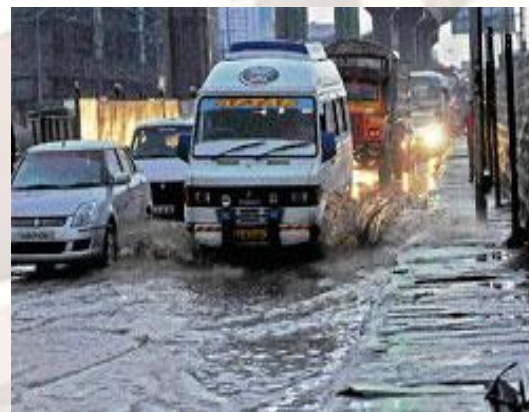
Fig. 10: Flash Flooding, alongside walkway.

The area presently is a mute witness to Air Quality Index (AQI) of 256, which incidentally falls under the category/rating of 'Severe Air Pollution'. Coincidentally, even the average daily 'maximum' and 'minimum' noise levels have been observed to be above 92 and 62 dB, both being above city tolerance levels. All along this, the stretch is already experiencing flash floods during rainy seasons (figure 10), due to clogged drains, compounded by the fact that it is located at a lower
