River Restoration— A Study of River Musi and Analysis on Influence of Urbanisation

Abstract - Water is a very essential element in formation of any livelihood. When we take a close look at the source of water in the present scenario, most of the rivers bear sewage water and thousands of water bodies have already extinguished. One such example is The River Musi, which is a tributary of Krishna River in the Deccan plateau of Telangana, India. It flows through the historical city, Hyderabad and divides old city from new city.

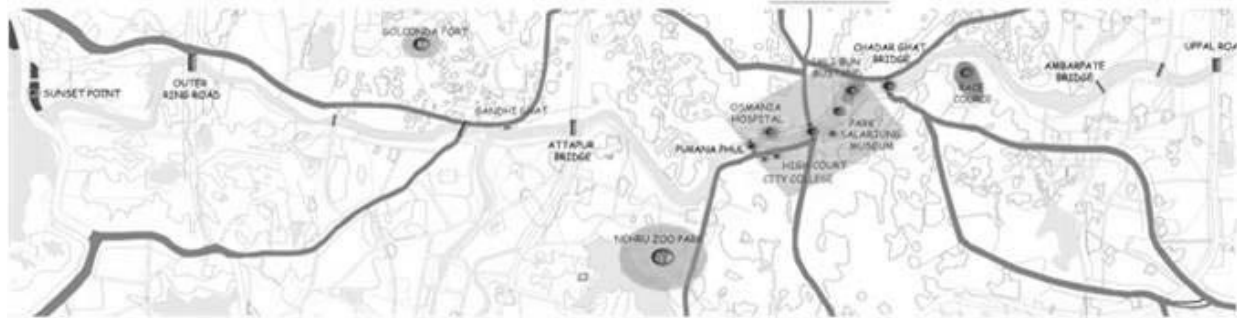
Fig 2: Zone of Influence

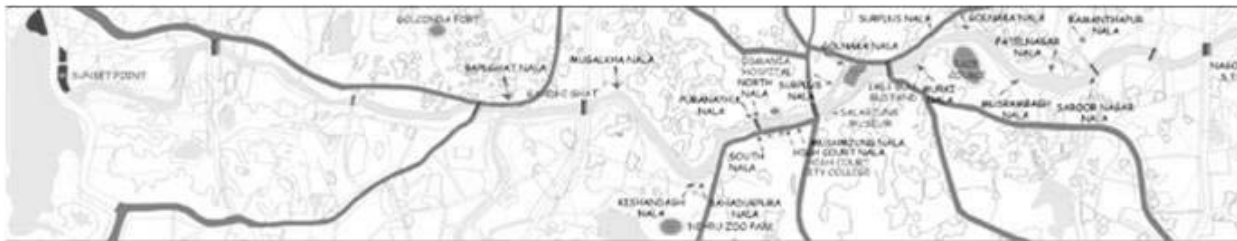
Fig 3: Sewage Inlet points entering into the Musi

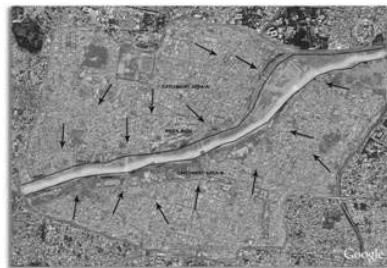
Fig.4: Water shed area of Old city (10)

4) *Catchment area calculation*[10]

Area of catchments = 321.6 HA (321,6070 sq.m) Average annual rainfall = 803 mm (0.803 M)

Area of catchments = 364.5 HA (364,5933 sq.m) Average annual rainfall = 803mm (0.803 m)
